# Rosebud County

## HIGH HAZARD LOCATION STUDY

Robert Peccia &  
Associates

December 1982

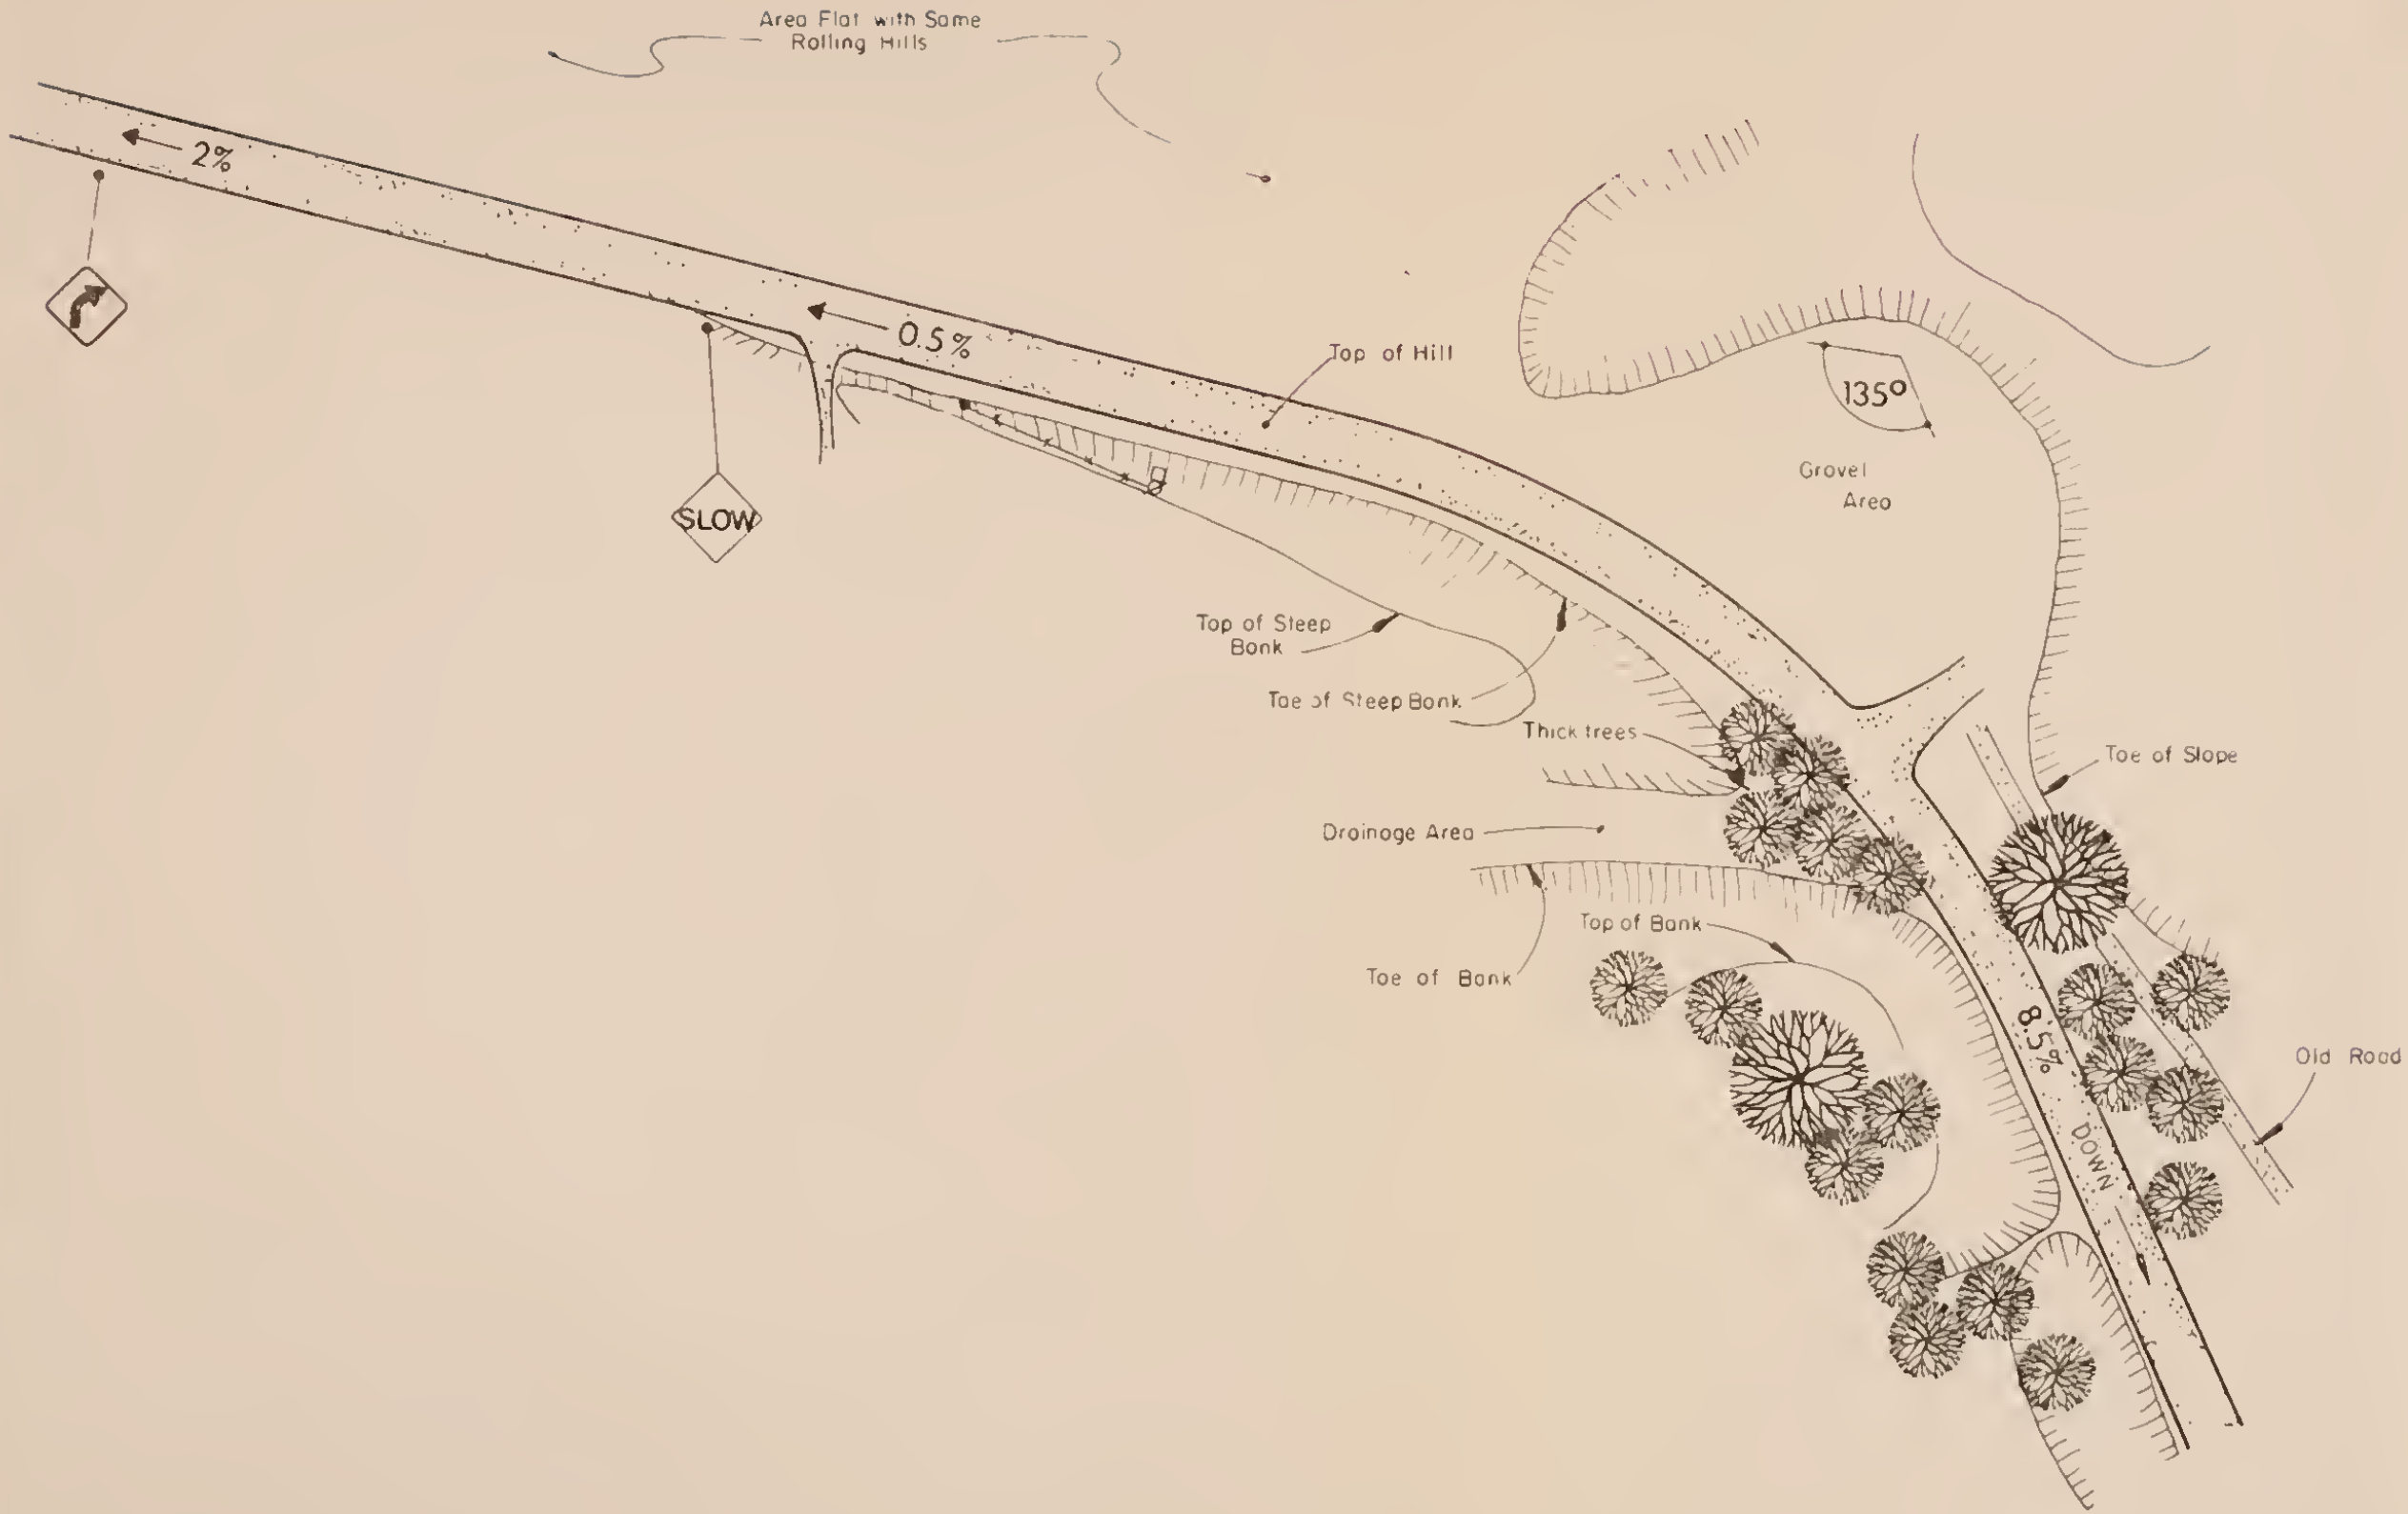
Figure No.  
**I-B**  
Rosebud

The gravel-surfaced roadway at this site varies from 24 to 28 feet in width. Grades on the west approach to the curve range from 0.5 to 2.0 percent to the west. A long downgrade which begins in the curve and extends eastward attains a maximum grade of approximately 8.5 percent. This grade, coupled with the extreme "washboard" road surface and large gravel surface material in places, makes for difficult conditions for motorists on the hill. Based on field observations, it is evident that many vehicles, especially heavy farm trucks, have trouble negotiating the hill and have difficulty maintaining even minimal travel speeds. Sight distance on the curve-hill combination varies from 170 feet for eastbound drivers to 210 feet for westbound motorists. Signing at the site consists of a curve warning sign (W1-2R) located approximately 500 feet from the curve and a non-standard "Slow" sign located approximately 250 feet from the beginning of the steep grade. There are no posted speed limit signs near the site, so it is assumed that the speed limit is 55 mph throughout the site. Because of the nature of the soils and base materials in the area, steep terrain tends to erode quite easily. There are several locations on the downgrade where washouts up to three feet deep extend dangerously close to the lanes of travel. Site conditions are depicted in Figure 1B and in the photographs contained in Plate 1.

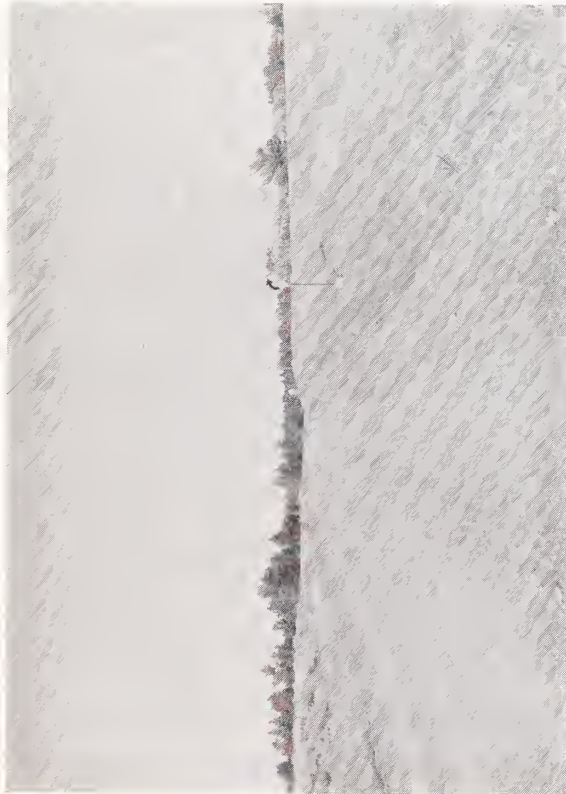
View of west approach to curve on Cartersville Road.

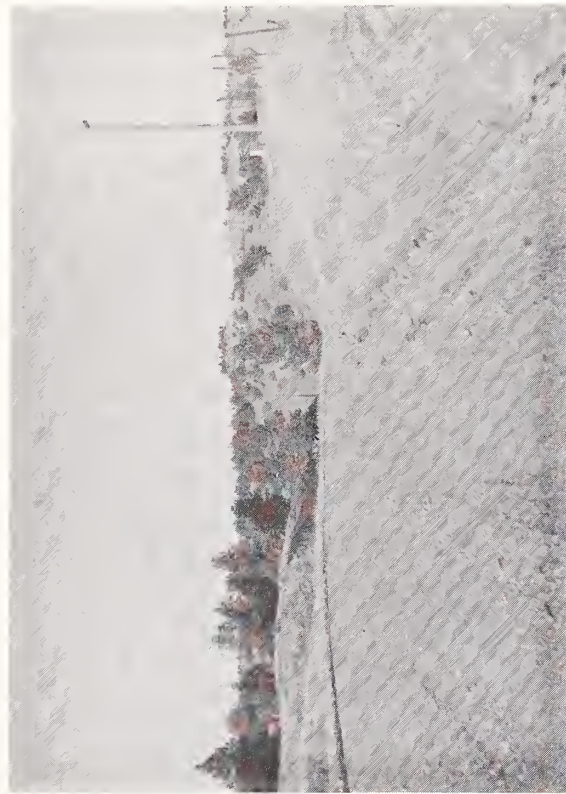
West approach to curve at top of hill. Note sight distance limitation resulting from curvature and grade change.

1. A vehicle equipped with a ball bank indicator was used to identify the maximum safe speed for the curve at this site. It was determined that a speed of 25 mph is appropriate for this location. According to the Manual on Uniform Traffic Control Devices, the existing curve warning sign (W1-2) located on the west approach should be used only for curves with recommended speeds between 30 and 60 mph. The more appropriate turn warning sign (W1-1) which is used for curves with recommended speeds of 30 mph or less, should be used. It is recommended that the existing curve warning sign be removed and replaced with a turn warning sign accompanied by a 25 mph advisory speed plate (W13-1). A similar combination of signs should be installed on the east approach approximately 250 feet from the beginning of the curve.

2. The non-standard "Slow" sign located on the west approach does not convey the most appropriate warning. It is recommended that this sign be replaced with a hill warning sign (W7-1). The hill warning sign conveys a warning or caution to the motorist while also properly identifying the upcoming situation.

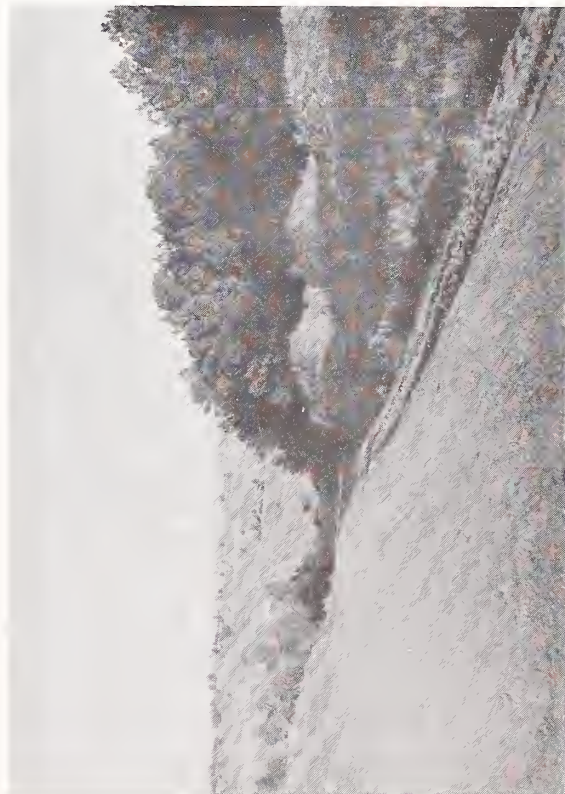
View of east approach to curve. Note the "washboard" surface of the gravel roadway. The grade at this location within the site is 8.5 percent. Also note steep areas adjacent to the roadway.

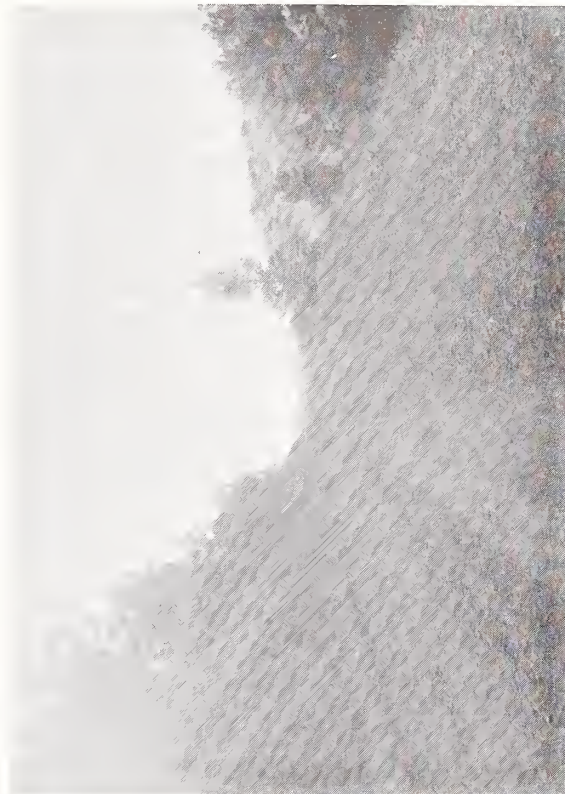
View of east approach to the curve. Note sight distance limitations experienced at the top of the hill. This situation is compounded by blinding sun conditions during the late afternoon and early evening hours.

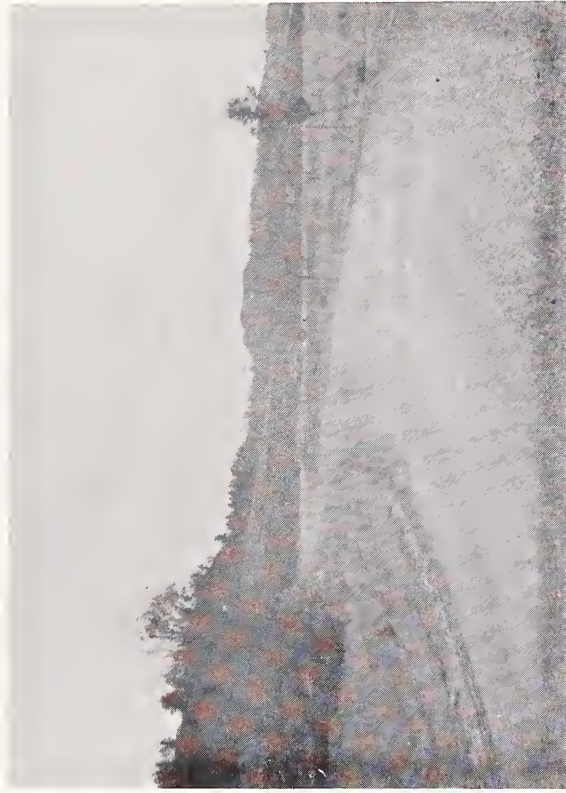
View of both reverse curves in the site. Note the deteriorated pavement on the inside of the nearest curve.

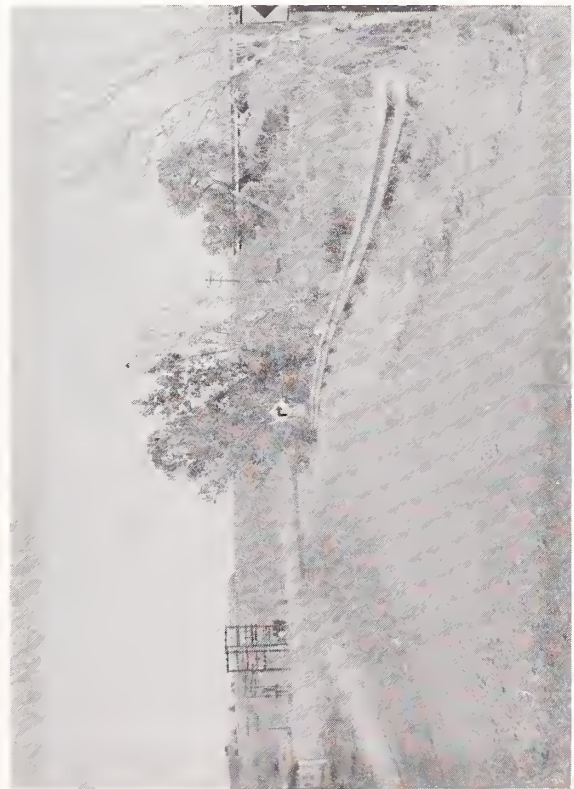
View of central portion of the site. Note sight distance limitation resulting from roadside vegetation in northernmost curve. The existing turn sign is mounted below standard height.

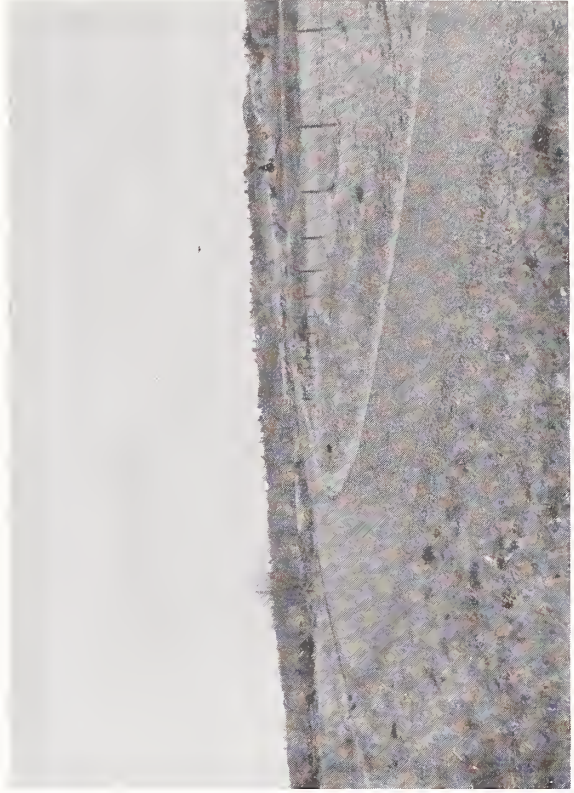
View of south approach to the site. Note long tangent section leading into the sharp turn. The majority of the accidents at this site occurred at this turn.

2. The accident history of this site indicates that most accidents involved northbound vehicles. It is therefore recommended that the curve delineation be improved for both approaches, with extra emphasis on the northbound lane. The existing directional arrow on the outside of the southernmost curve should be removed and a series of chevron warning signs (W1-8) in-

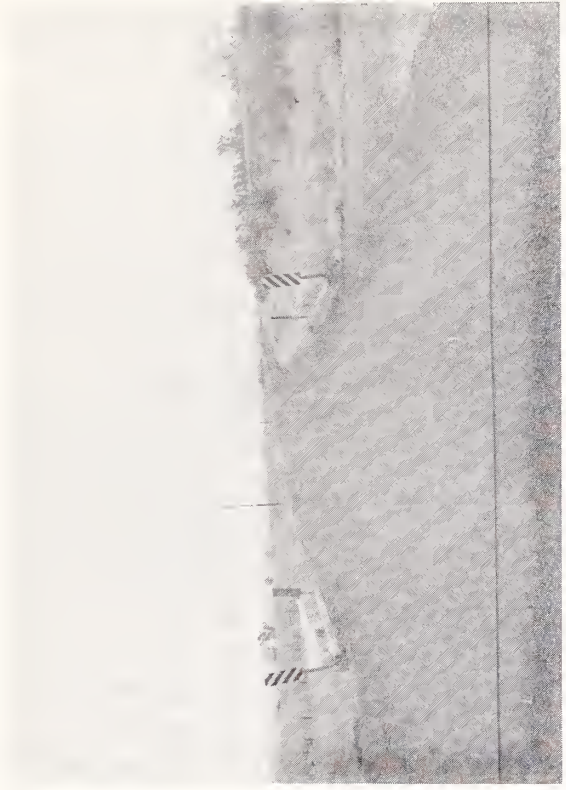
View of east approach to the bridge. Note long, straight tangent section leading into the broad curve at the bridge.

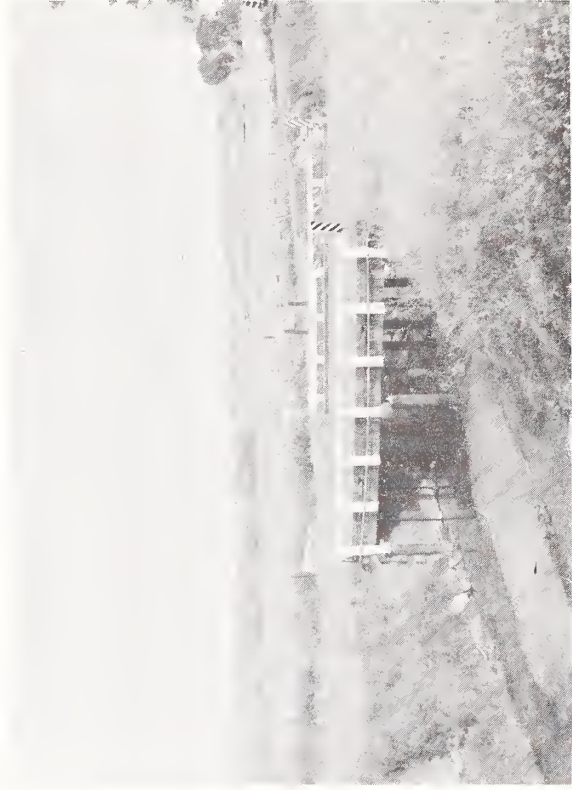
Sand Creek Bridge is a wooden structure with a two-inch asphalt surfaced deck. The bridge is 40 feet long and 28 feet wide and is in good structural condition.

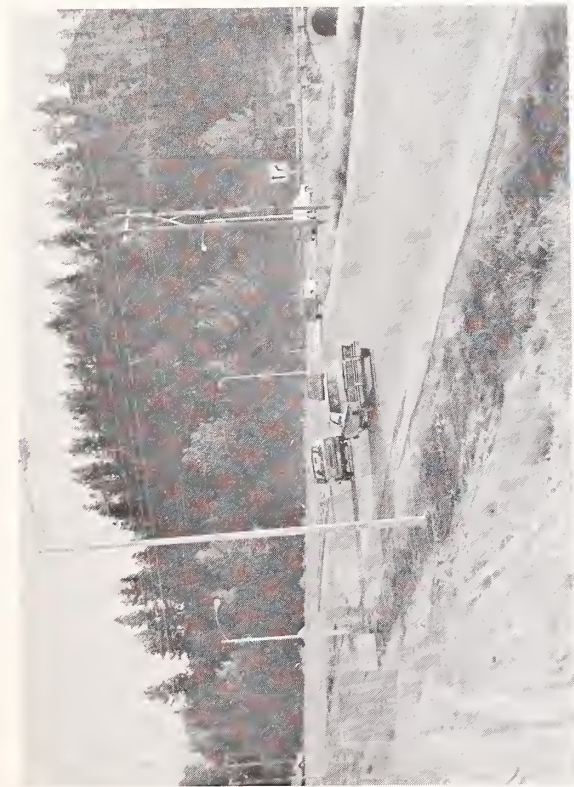
View of north leg of the intersection (Pine Butte Drive) depicting the existing signing and traffic channelization.

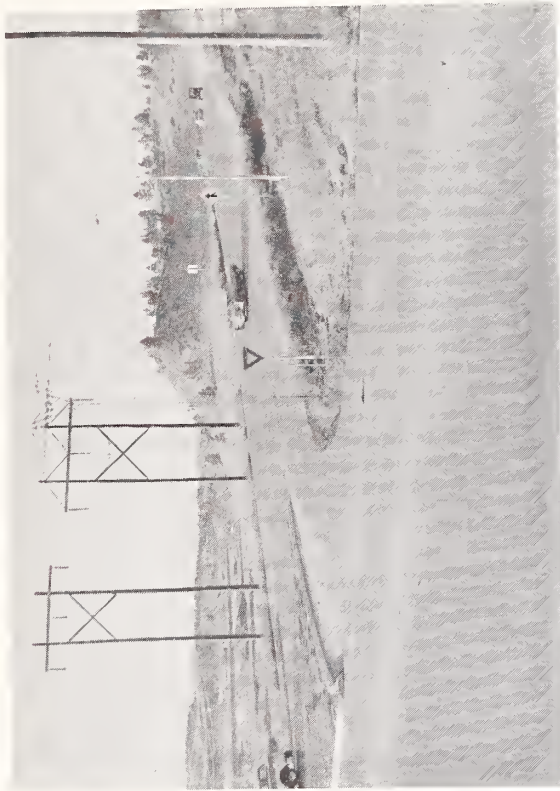
View of intersection from east approach. Note signing, channelization, lighting and delineation at the intersection.

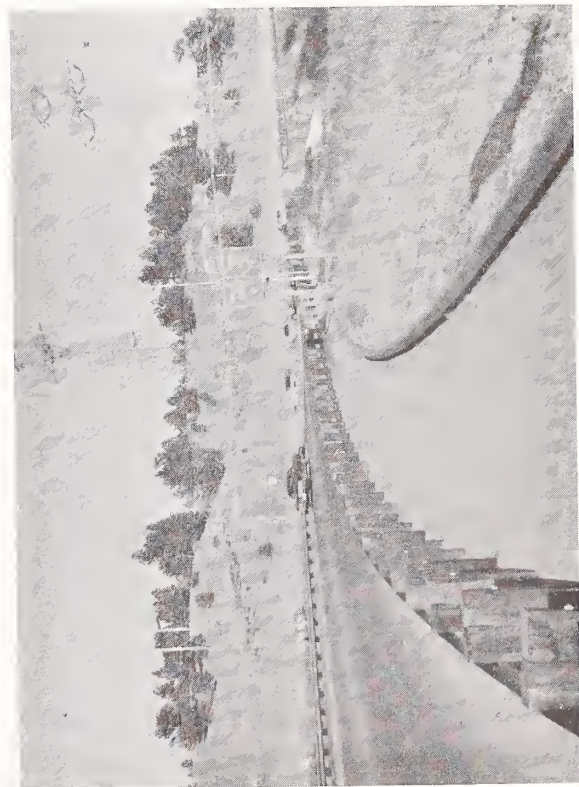
View of west approach to intersection (Power Road). Note pedestrian facilities adjacent to the roadway.

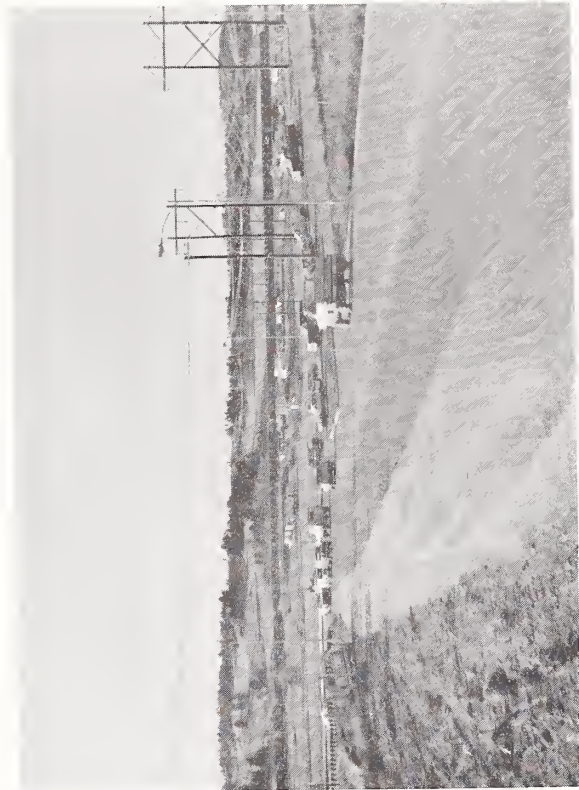
Peak hour traffic at intersection during October, 1982.
